Manhole Inspection Summary

Manhole # S29Q1_029MH

Location Address: **2831 Spelman Rd.**

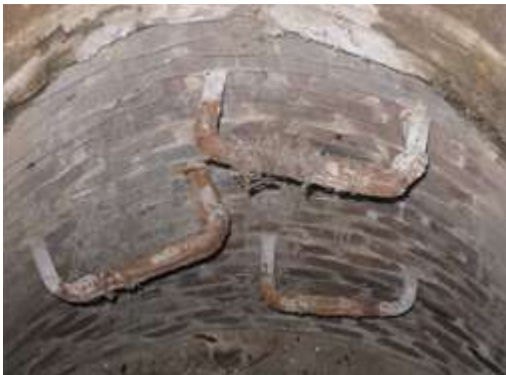
Steps Count: **3** Missing: **0** ☒ Corroded

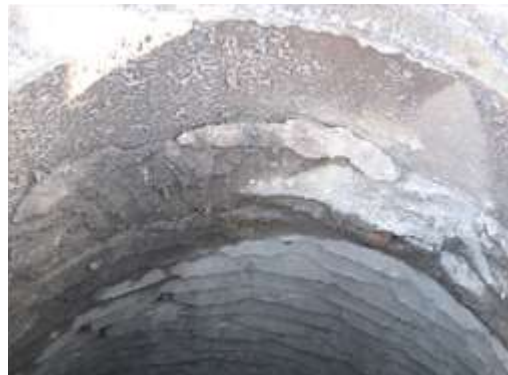
Defect 1

Infiltration: ☐ None ☐ Joint ☐ Cracks ☒ Mortar ☐ Roots ☒ Wall

Mortar

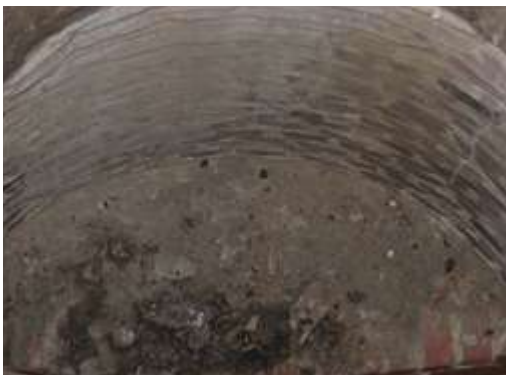
Defect 2

Infiltration: ☐ None ☐ Joint ☐ Cracks ☐ Mortar ☐ Roots ☒ Wall

Wall

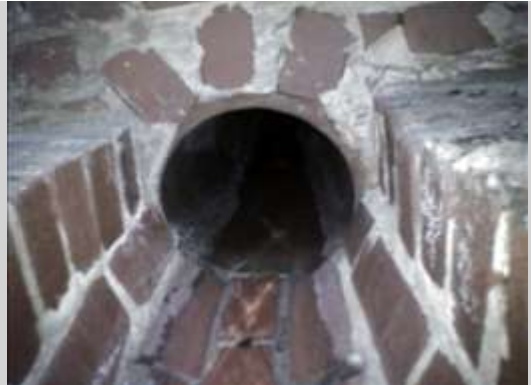
12 O'Clock Outflow

8 in. Circular Gravity Sewer
Pipe Out @ 12 O'Clock

Pipe Height: **8.4** (in.) Rod and Bar (Angled)
Pipe Material: **Clay** ☐ Pipe Lined
Invert Depth: **7.21** (ft.) Flow Characteristics: **Fast**
Deposits: ☒ None ☐ Mud ☐ Sludge ☐ Debris ☐ Grease
Silt Depth: (in.) Deposits Extent:
Infiltration: **None** Pipe Seal Cond: **Sound**

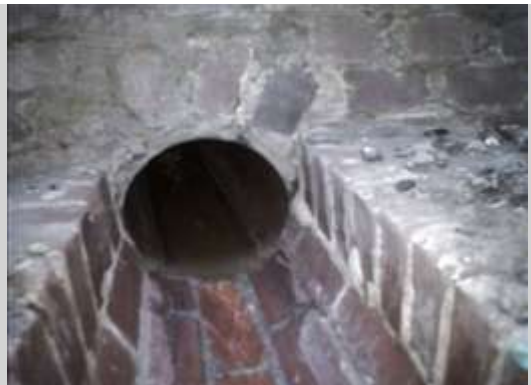
6 O'Clock Inflow

8 in. Circular Gravity Sewer
Pipe In @ 6 O'Clock

Pipe Height: **8.4** (in.) Rod and Bar (Angled)
Pipe Material: **Clay** ☐ Pipe Lined
Invert Depth: **7.09** (ft.) Flow Characteristics: **Fast**
Deposits: ☒ None ☐ Mud ☐ Sludge ☐ Debris ☐ Grease
Silt Depth: (in.) Deposits Extent:
Infiltration: **None** Pipe Seal Cond: **Sound**
